CCR SURFACE IMPOUNDMENT EMERGENCY ACTION PLAN

Plant Miller

ISSUE DATE: APRIL 17, 2017
REVISION #: 0

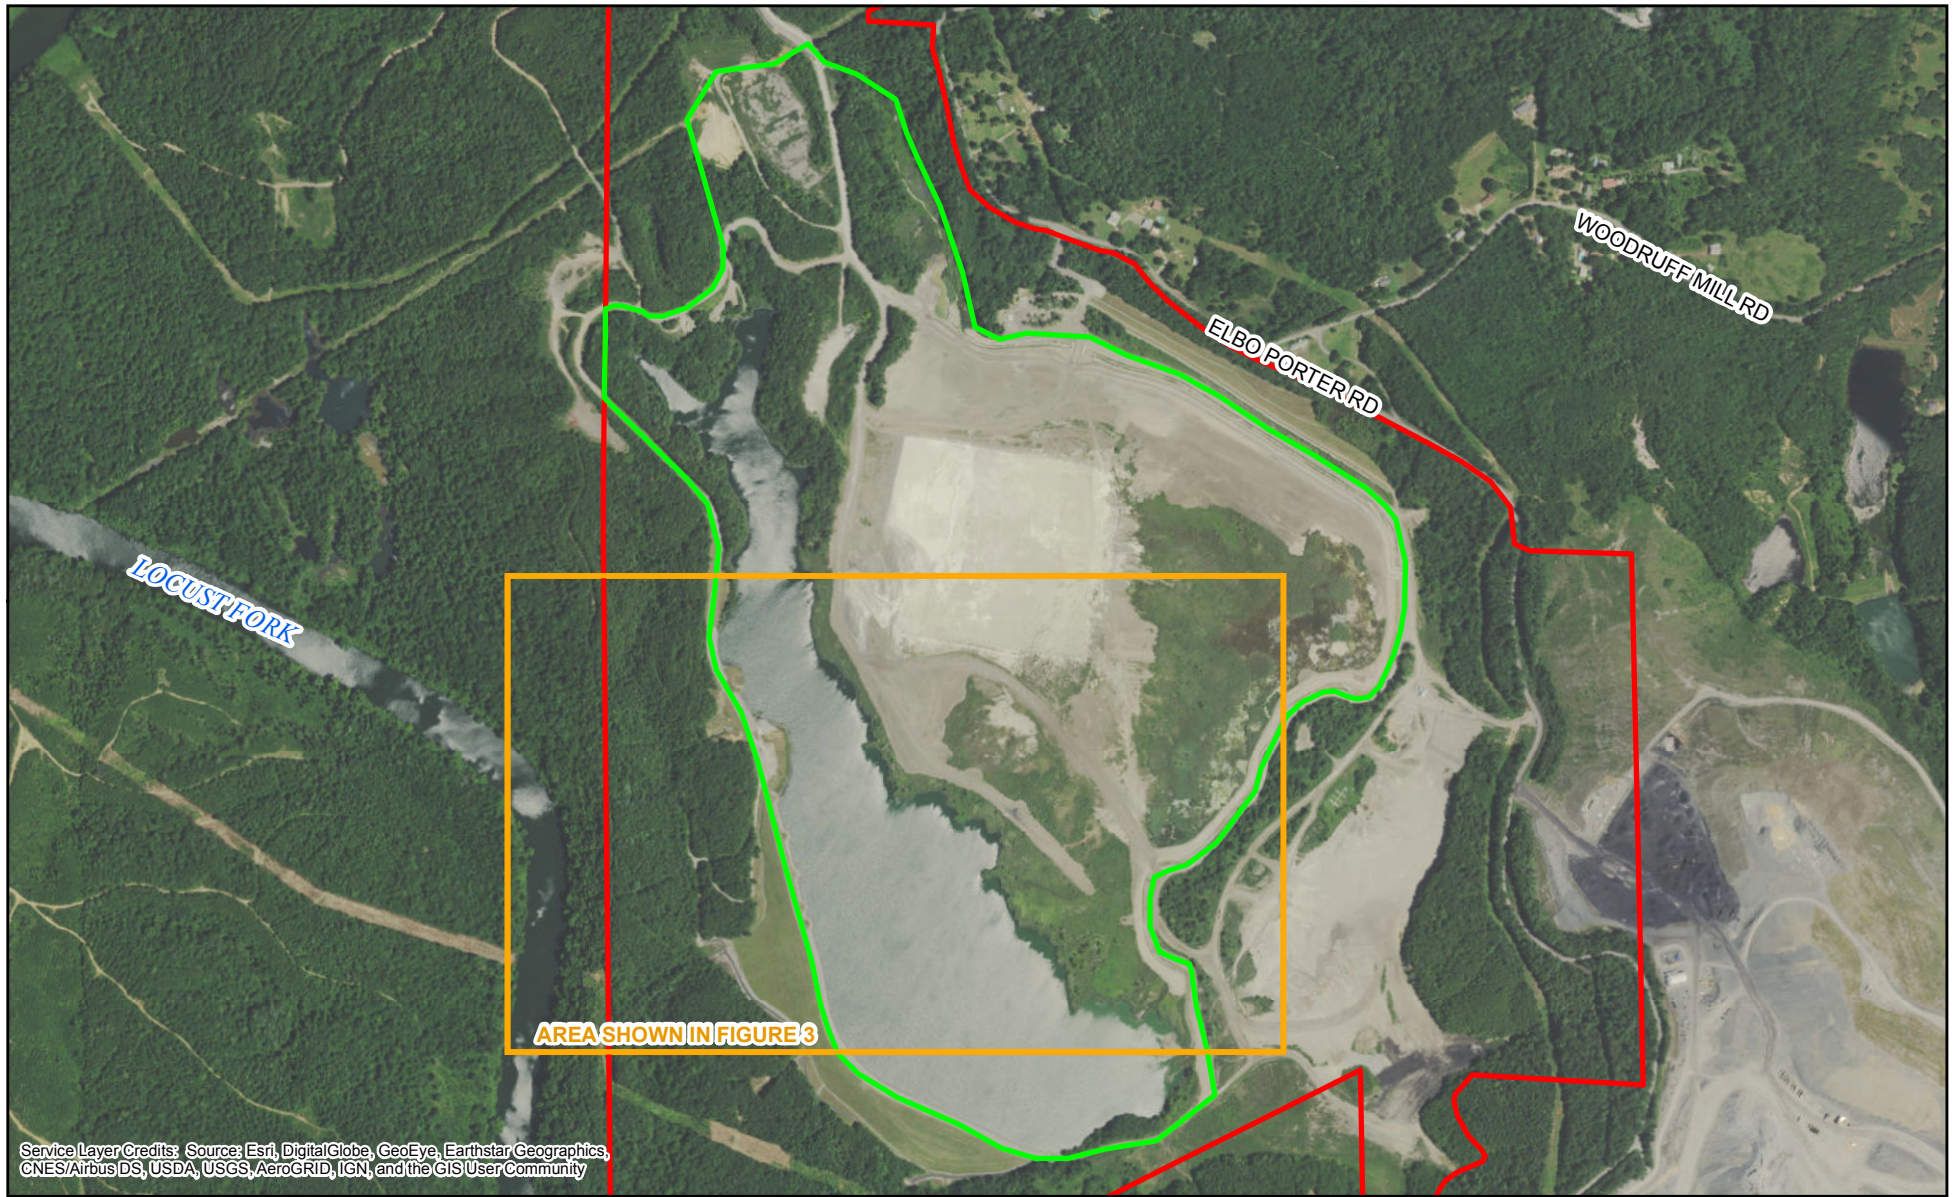
FIGURE 2
ASH POND OVERVIEW
PLANT MILLER
JEFFERSON COUNTY, GEORGIA

The Ash Pond is approximately 321 acres in size at its normal pool elevation of 420.5 feet (Appendix A – Figure 2 and Figure 3). The Ash Pond was formed with a cross-valley embankment along the south side, and a saddle dike along a portion of the north side. Both have a crest elevation of about 426 feet. A majority of the slopes are vegetated, with some areas covered with riprap. The crest surface is composed of grass and a granular access drive. The surface impoundment outlet structure consists of a 96-in diameter concrete riser structure that directs flow to a 96-in diameter concrete discharge pipe on the south side of the embankment. The surface impoundment and discharge structure are designed and operated to safely manage the 1000-yr storm event.

Ash Pond Overview – Figure 2

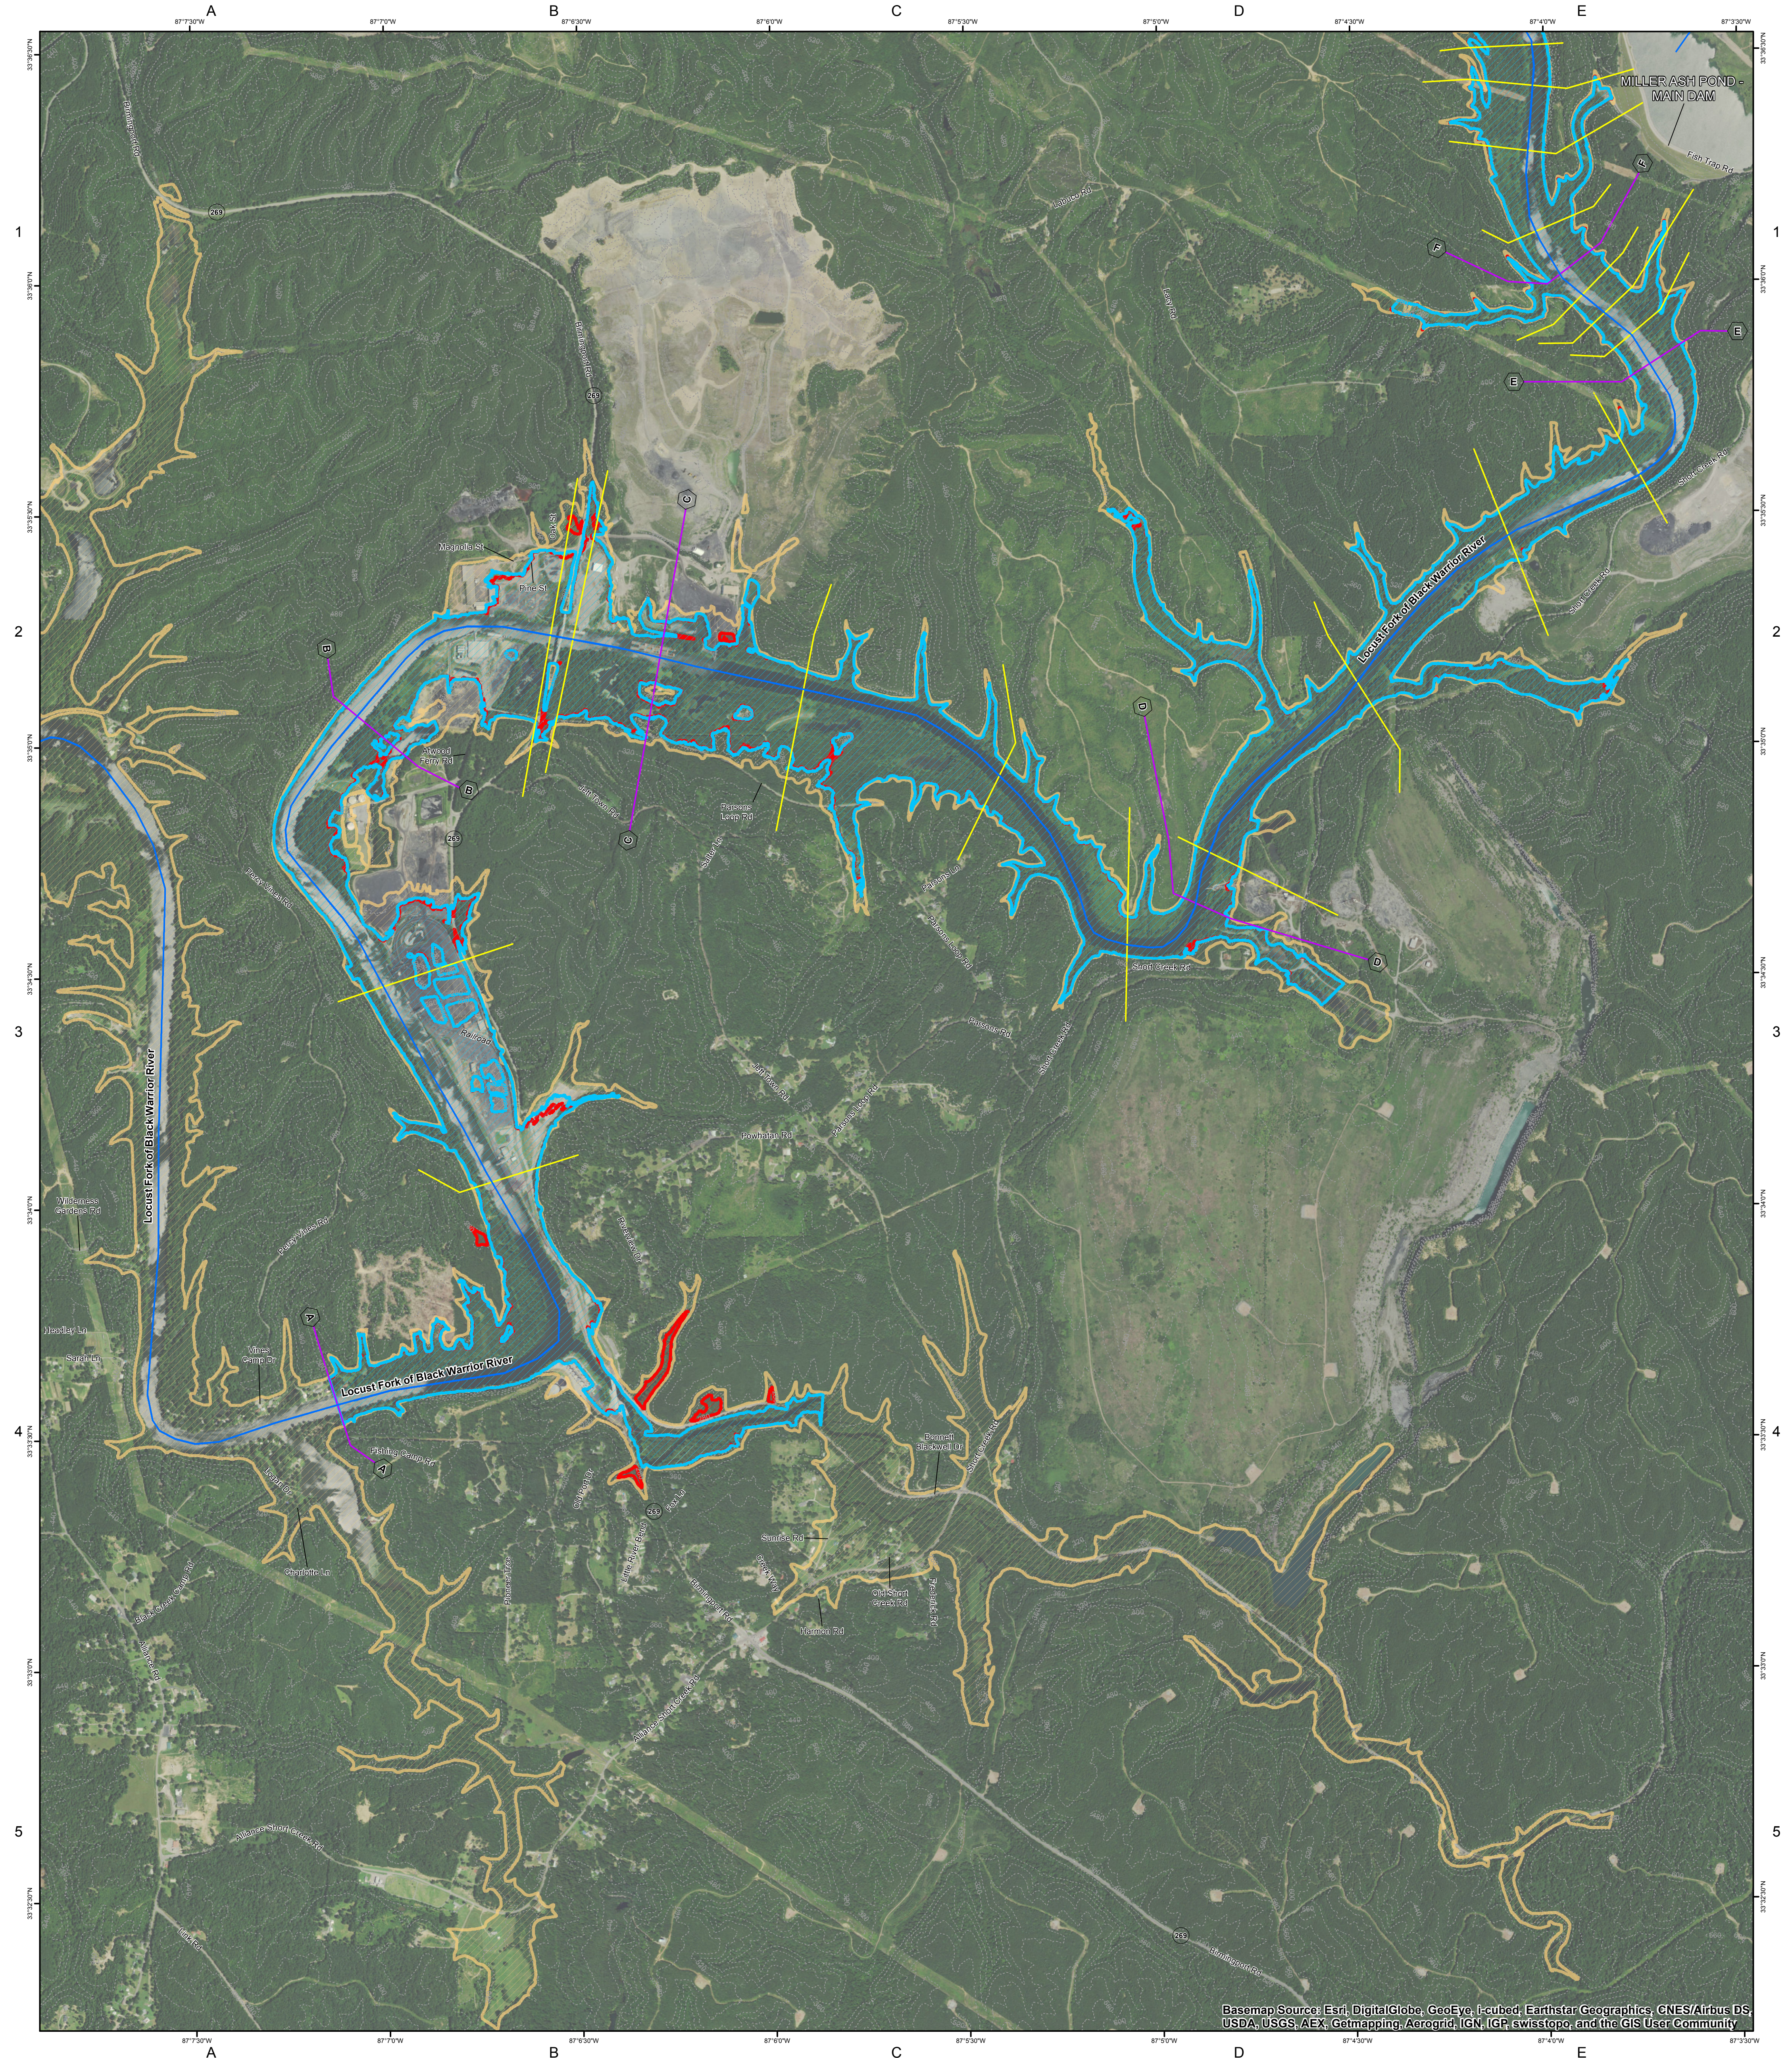
Ash Pond Dam Inundation Analysis

Normal river/lake levels and the flow from simulated dam breaches were superimposed over topographical maps to identify areas subject to flooding. ***These flood extents are provided for planning purposes only; actual flooding can vary due to actual conditions present at the time of the failure.***

Main Dam - Design Storm Breach						
Cross Section	Distance from Dam (miles)	Time to Initial Wave (hours)	Time to Max Wave (hours)	10-year River Elevation (NAVD, feet)	Max Breach WSEL (NAVD, feet)	Elevation Increase (Max WSEL - 10-year) (feet)
A	7.48 ¹	0:42	2:53	269.9	272.1	2.2
B	5.10 ¹	0:25	1:77	271.9	274.8	2.9
C	4.25 ¹	0:17	1:52	272.8	275.9	3.1
D	2.56 ¹	0:08	1:18	274.3	278.3	4.0
E	0.65 ¹	0:00	1:07	276.3	281.9	5.6
F	0.33 ¹	0:00	0:52	276.7	283.5	6.8
G	0.39 ²	0:00	0:98	277.7	284.5	6.8
H	1.41 ²	0:08	1:00	279.1	285.3	6.2
I	2.35 ²	0:17	0:93	279.7	285.6	5.9
J	3.13 ²	0:25	0:88	280.2	285.9	5.7
K	3.64 ²	0:33	0:90	281.0	286.1	5.1
L	4.40 ²	0:42	0:93	282.1	286.4	4.3
M	4.64 ²	0:42	0:98	283.4	287.2	3.8
N	5.28 ²	0:42	1:02	284.1	287.4	3.3
O	5.75 ²	0:50	1:10	284.9	287.7	2.8
P	6.55 ²	0:58	1:47	286.0	288.2	2.2
Q	6.80 ²	0:58	1:50	286.5	288.4	1.9

Note:
 1. The information contained in this map is prepared for use in notification of downstream property owners by emergency management personnel.
 2. Mapping of flooded areas and floodwave travel times are approximate. Timing and extent of actual inundation may differ from information presented on this map.
 3. It is prudent to assume that areas outside, but adjacent to, the inundation limits shown could also be flooded.
 4. The contours shown on this map were generated from the LiDAR Digital Elevation Model (DEM) for Jefferson County and the USGS 10-meter DEM for Walker County.

The Ash Pond has been assigned a Significant Hazard Potential classification under 40 C.F.R. Part 257.73 of the Environmental Protection Agency's (EPA's) Coal Combustion Residuals (CCR) Rule. This classification, by definition, indicates that there is no probable loss of human life in the event of a dam/dike failure or misoperation of the facility, but there is a potential for economic loss or environmental damage. There are no other dams located in close proximity downstream that could be impacted by the failure of the Ash Pond dam/dike. The limits of potential flooding in the event of failure of the Ash Pond dam/dike can be seen on the Inundation Maps, which are included as Appendix B. The provided inundation maps were developed based on the results of routing the breach wave downstream using the computer software, HEC-RAS. HEC-RAS is a general application one-dimensional hydraulic model that can perform unsteady flow routing through an open channel system that may also include culverts, bridges, levees, tributaries, storage areas, and other dams. Unsteady flow analyses allow for flow conditions that vary temporally and spatially such as a dam breach simulation. Breach parameters such as failure time, breach width, and breach side slopes were selected from industry accepted empirical formulas. Water surface elevation data was extracted from the hydraulic model and plotted on best available LiDAR topographic information for the downstream areas.

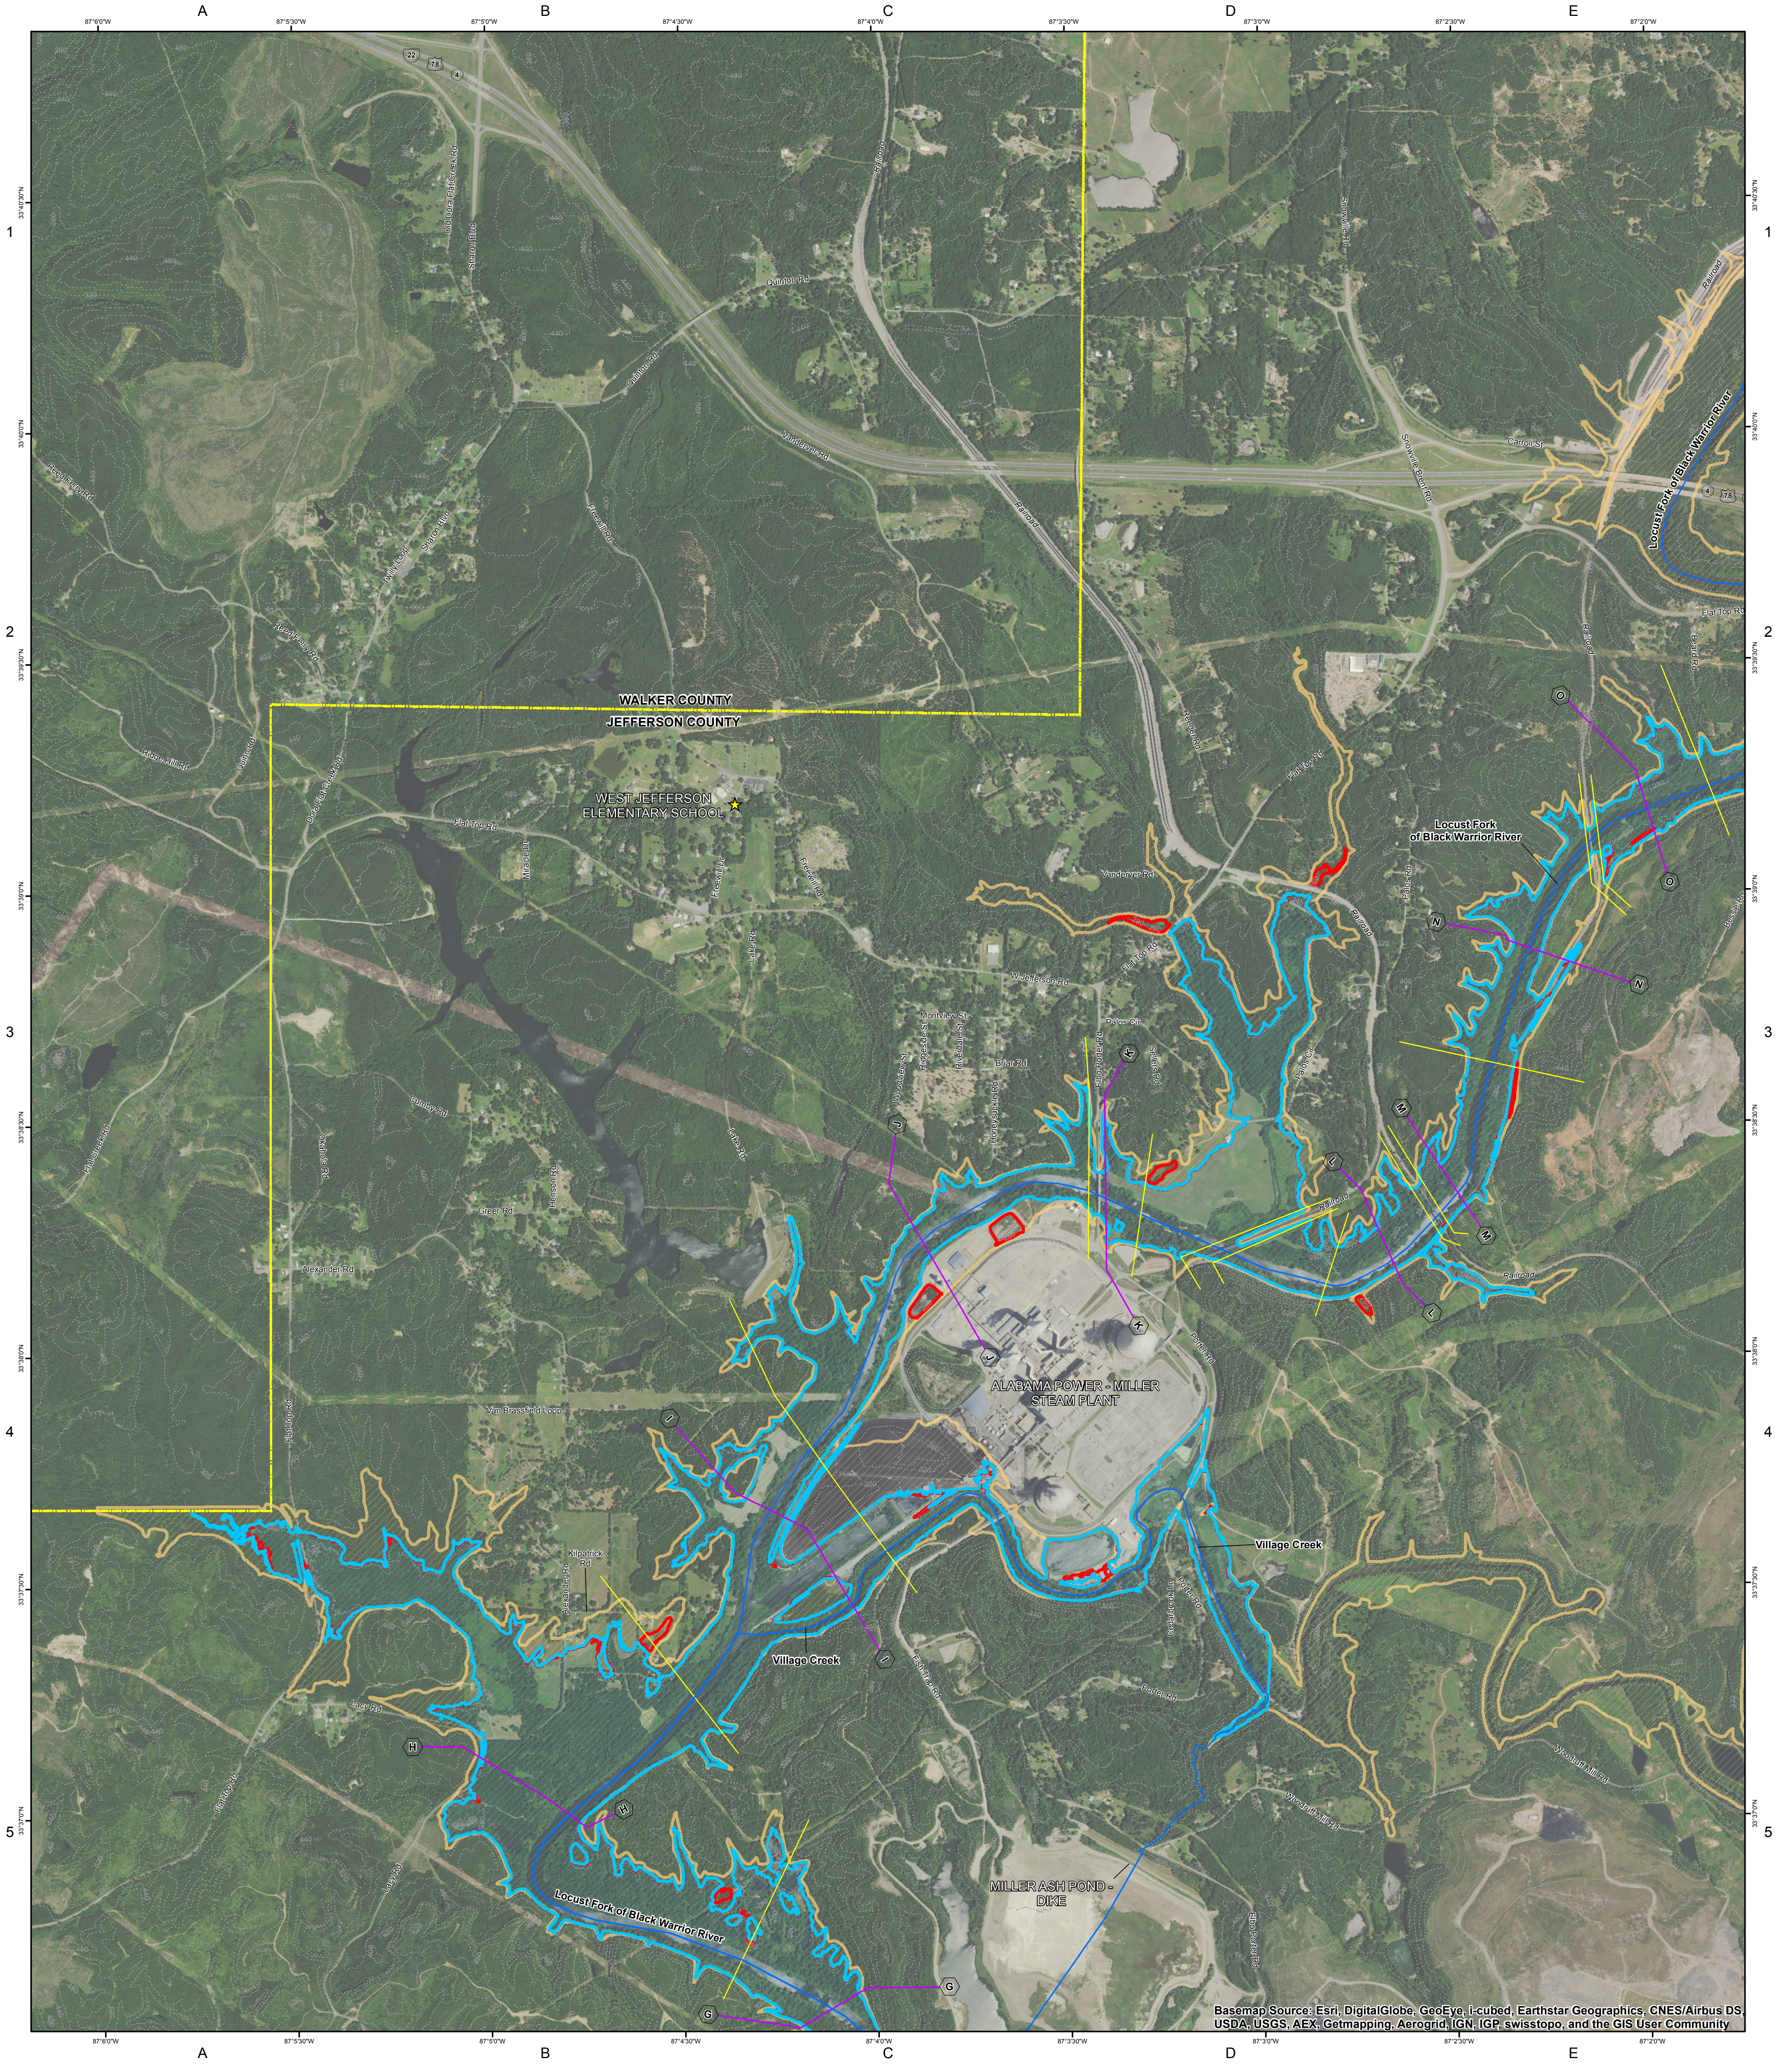
Main Dam - Design Storm Breach

Note:
 1. The information contained in this map is prepared for use in notification of downstream property owners by emergency management personnel.
 2. Mapping of flooded areas and floodwave travel times are approximate. Timing and extent of actual inundation may differ from information presented on this map.
 3. It is prudent to assume that areas outside, but adjacent to, the inundation limits shown could also be flooded.
 4. The contours shown on this map were generated from the LiDAR Digital Elevation Model (DEM) for Jefferson County and the USGS 10-meter DEM for Walker County.

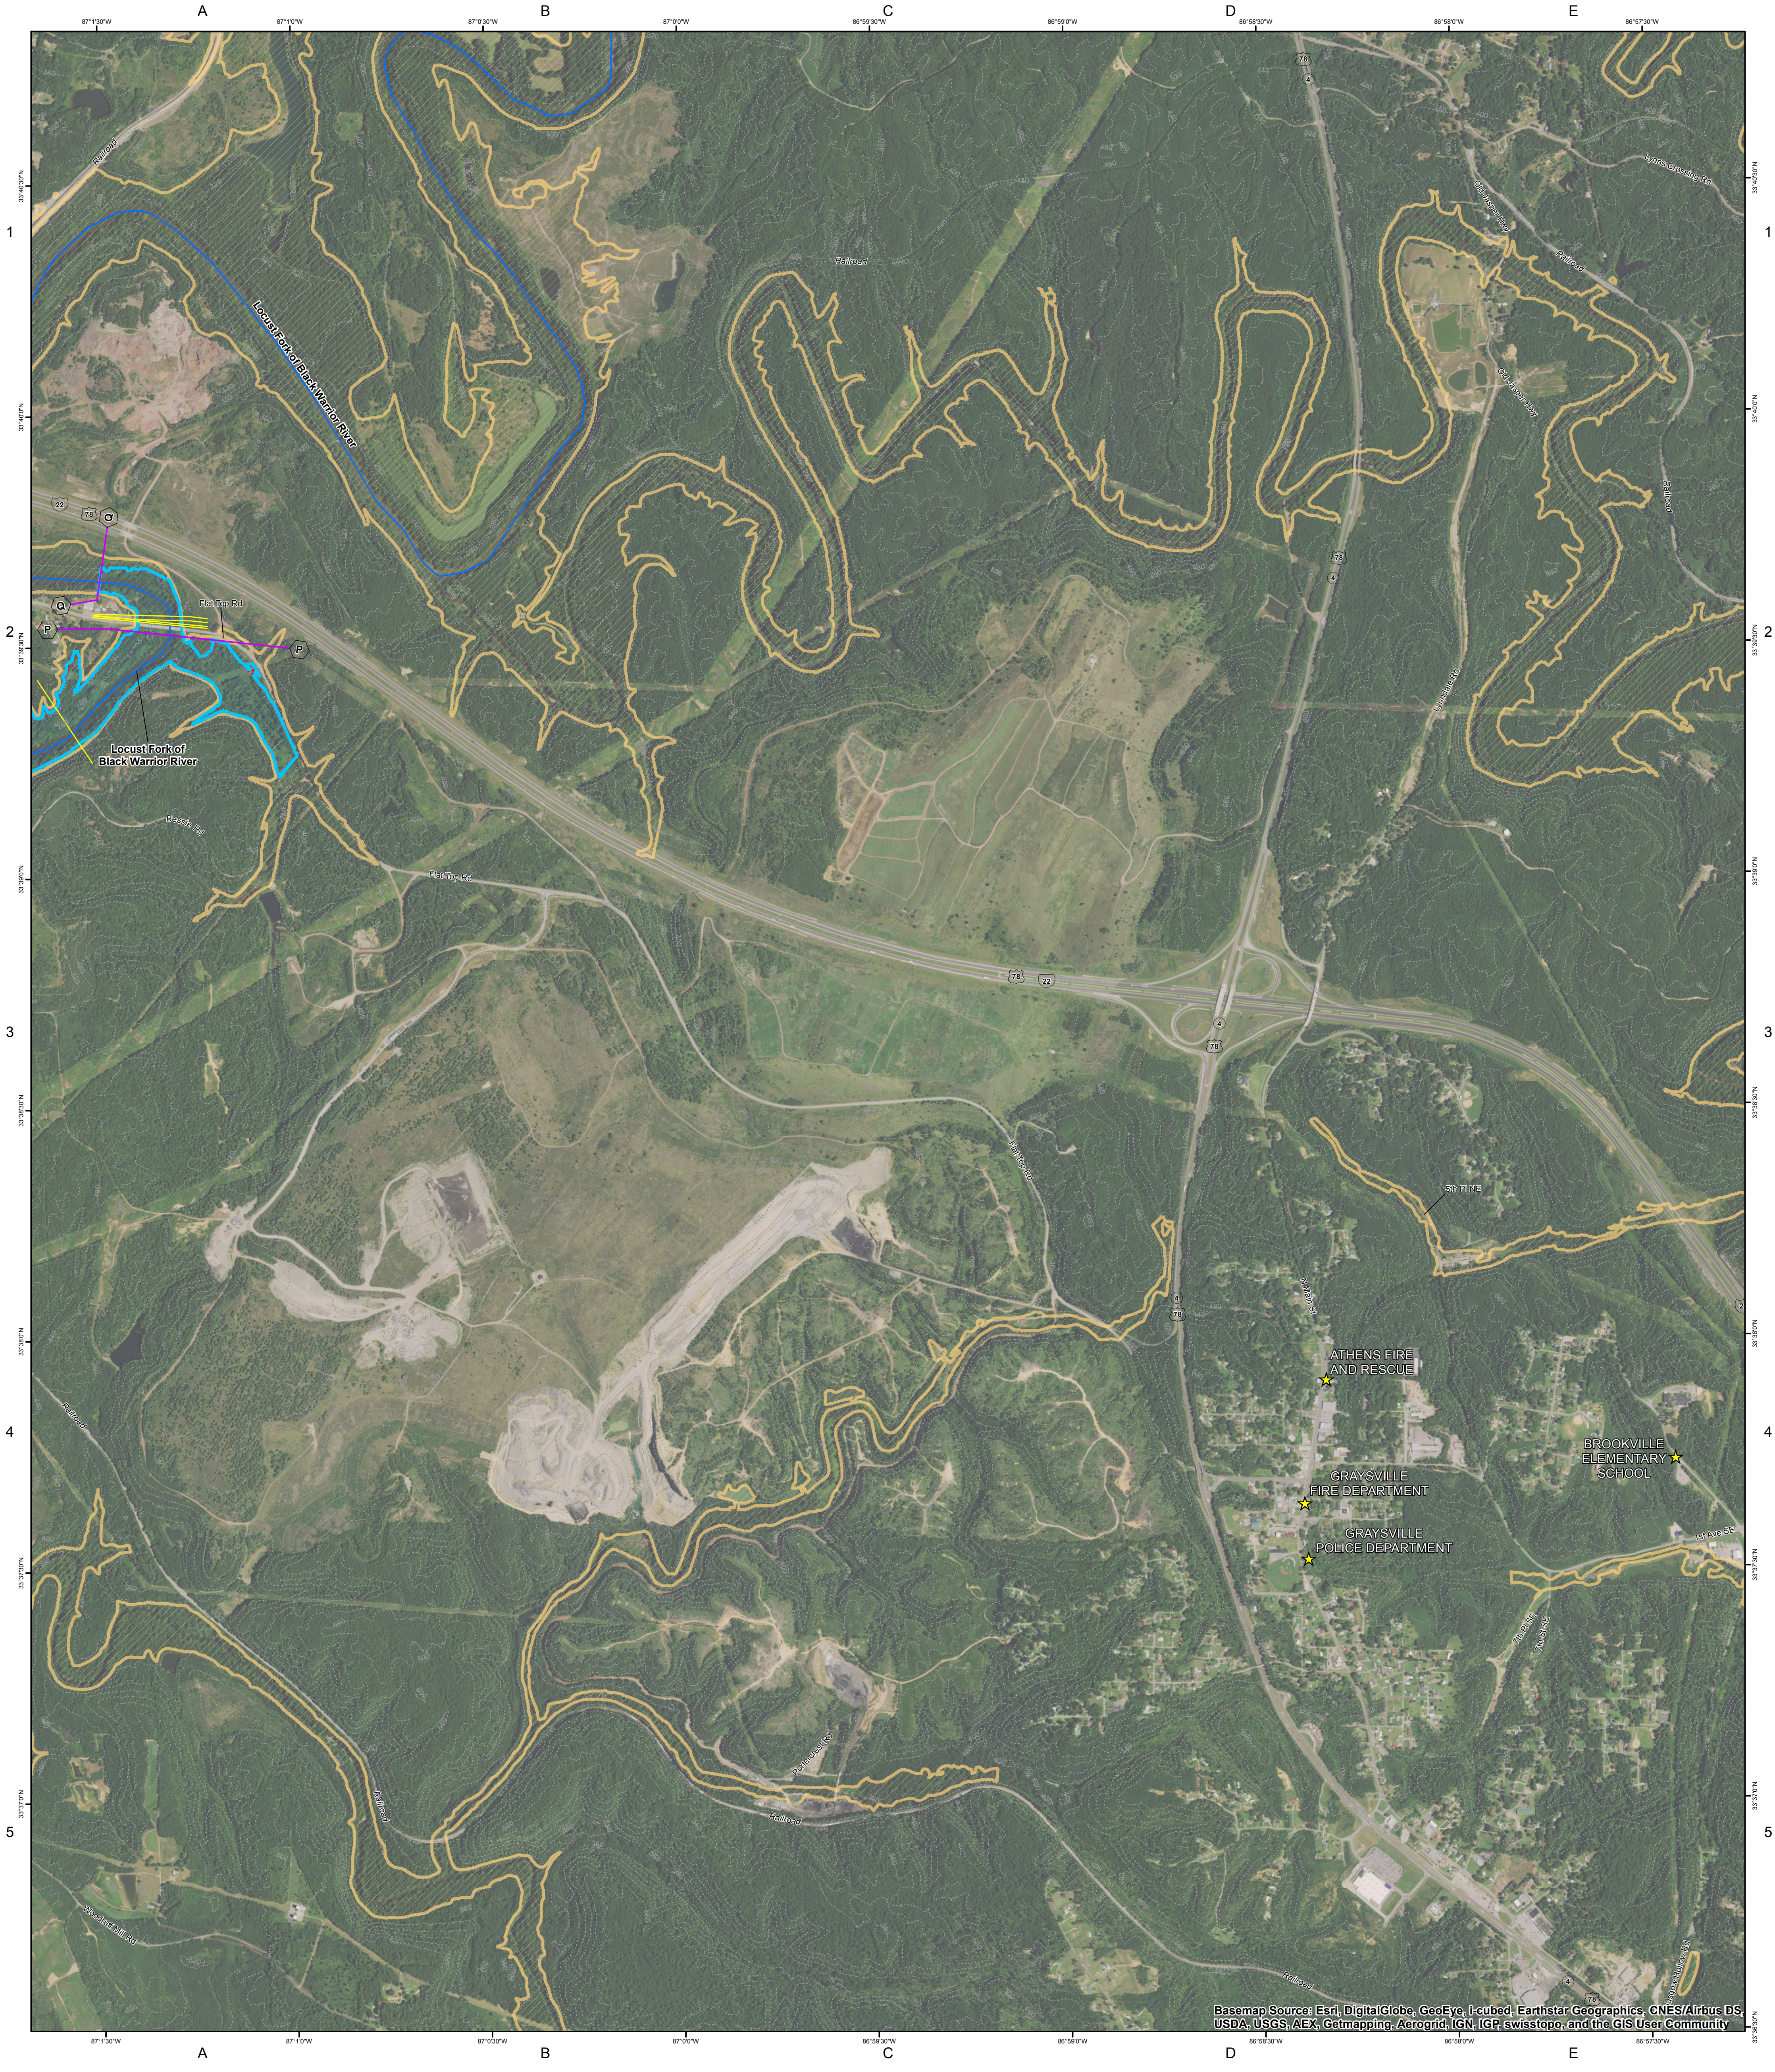
Main Dam - Design Storm Breach

Note:
 1. The information contained in this map is prepared for use in notification of downstream property owners by emergency management personnel.
 2. Mapping of flooded areas and floodwave travel times are approximate. Timing and extent of actual inundation may differ from information presented on this map.
 3. It is prudent to assume that areas outside, but adjacent to, the inundation limits shown could also be flooded.
 4. The contours shown on this map were generated from the LIDAR Digital Elevation Model (DEM) for Jefferson County and the USGS 10-meter DEM for Walker County.
