# CCR SURFACE IMPOUNDMENT EMERGENCY ACTION PLAN

## Plant Gaston Ash Pond

**ISSUE DATE:** April 15, 2022  
**REVISION #:** 1

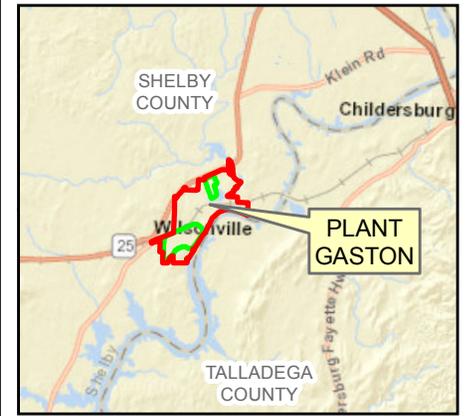
**Plant Gaston Location Map – Figure 1**  
**Ash Pond Overview – Figure 2**

Plant Gaston is a coal-fired power plant located near Wilsonville, Alabama. This EAP covers emergency response procedures for the Plant Gaston Ash Pond (the Ash Pond), which was designed to receive and store coal combustion residuals and low volume waste streams produced during the electric generating process at Plant Gaston. The Ash Pond no longer receives CCR nor low volume waste streams and is now undergoing closure construction. An overview of Plant Gaston and the surrounding area is shown in Appendix A – Figure 1.

Plant and emergency personnel are able to access the dam/dike from the main portion of Plant Gaston by paved or gravel-surfaced roadways. Figures 1 and 2 in Appendix A illustrate the location of the Ash Pond within the Plant property.

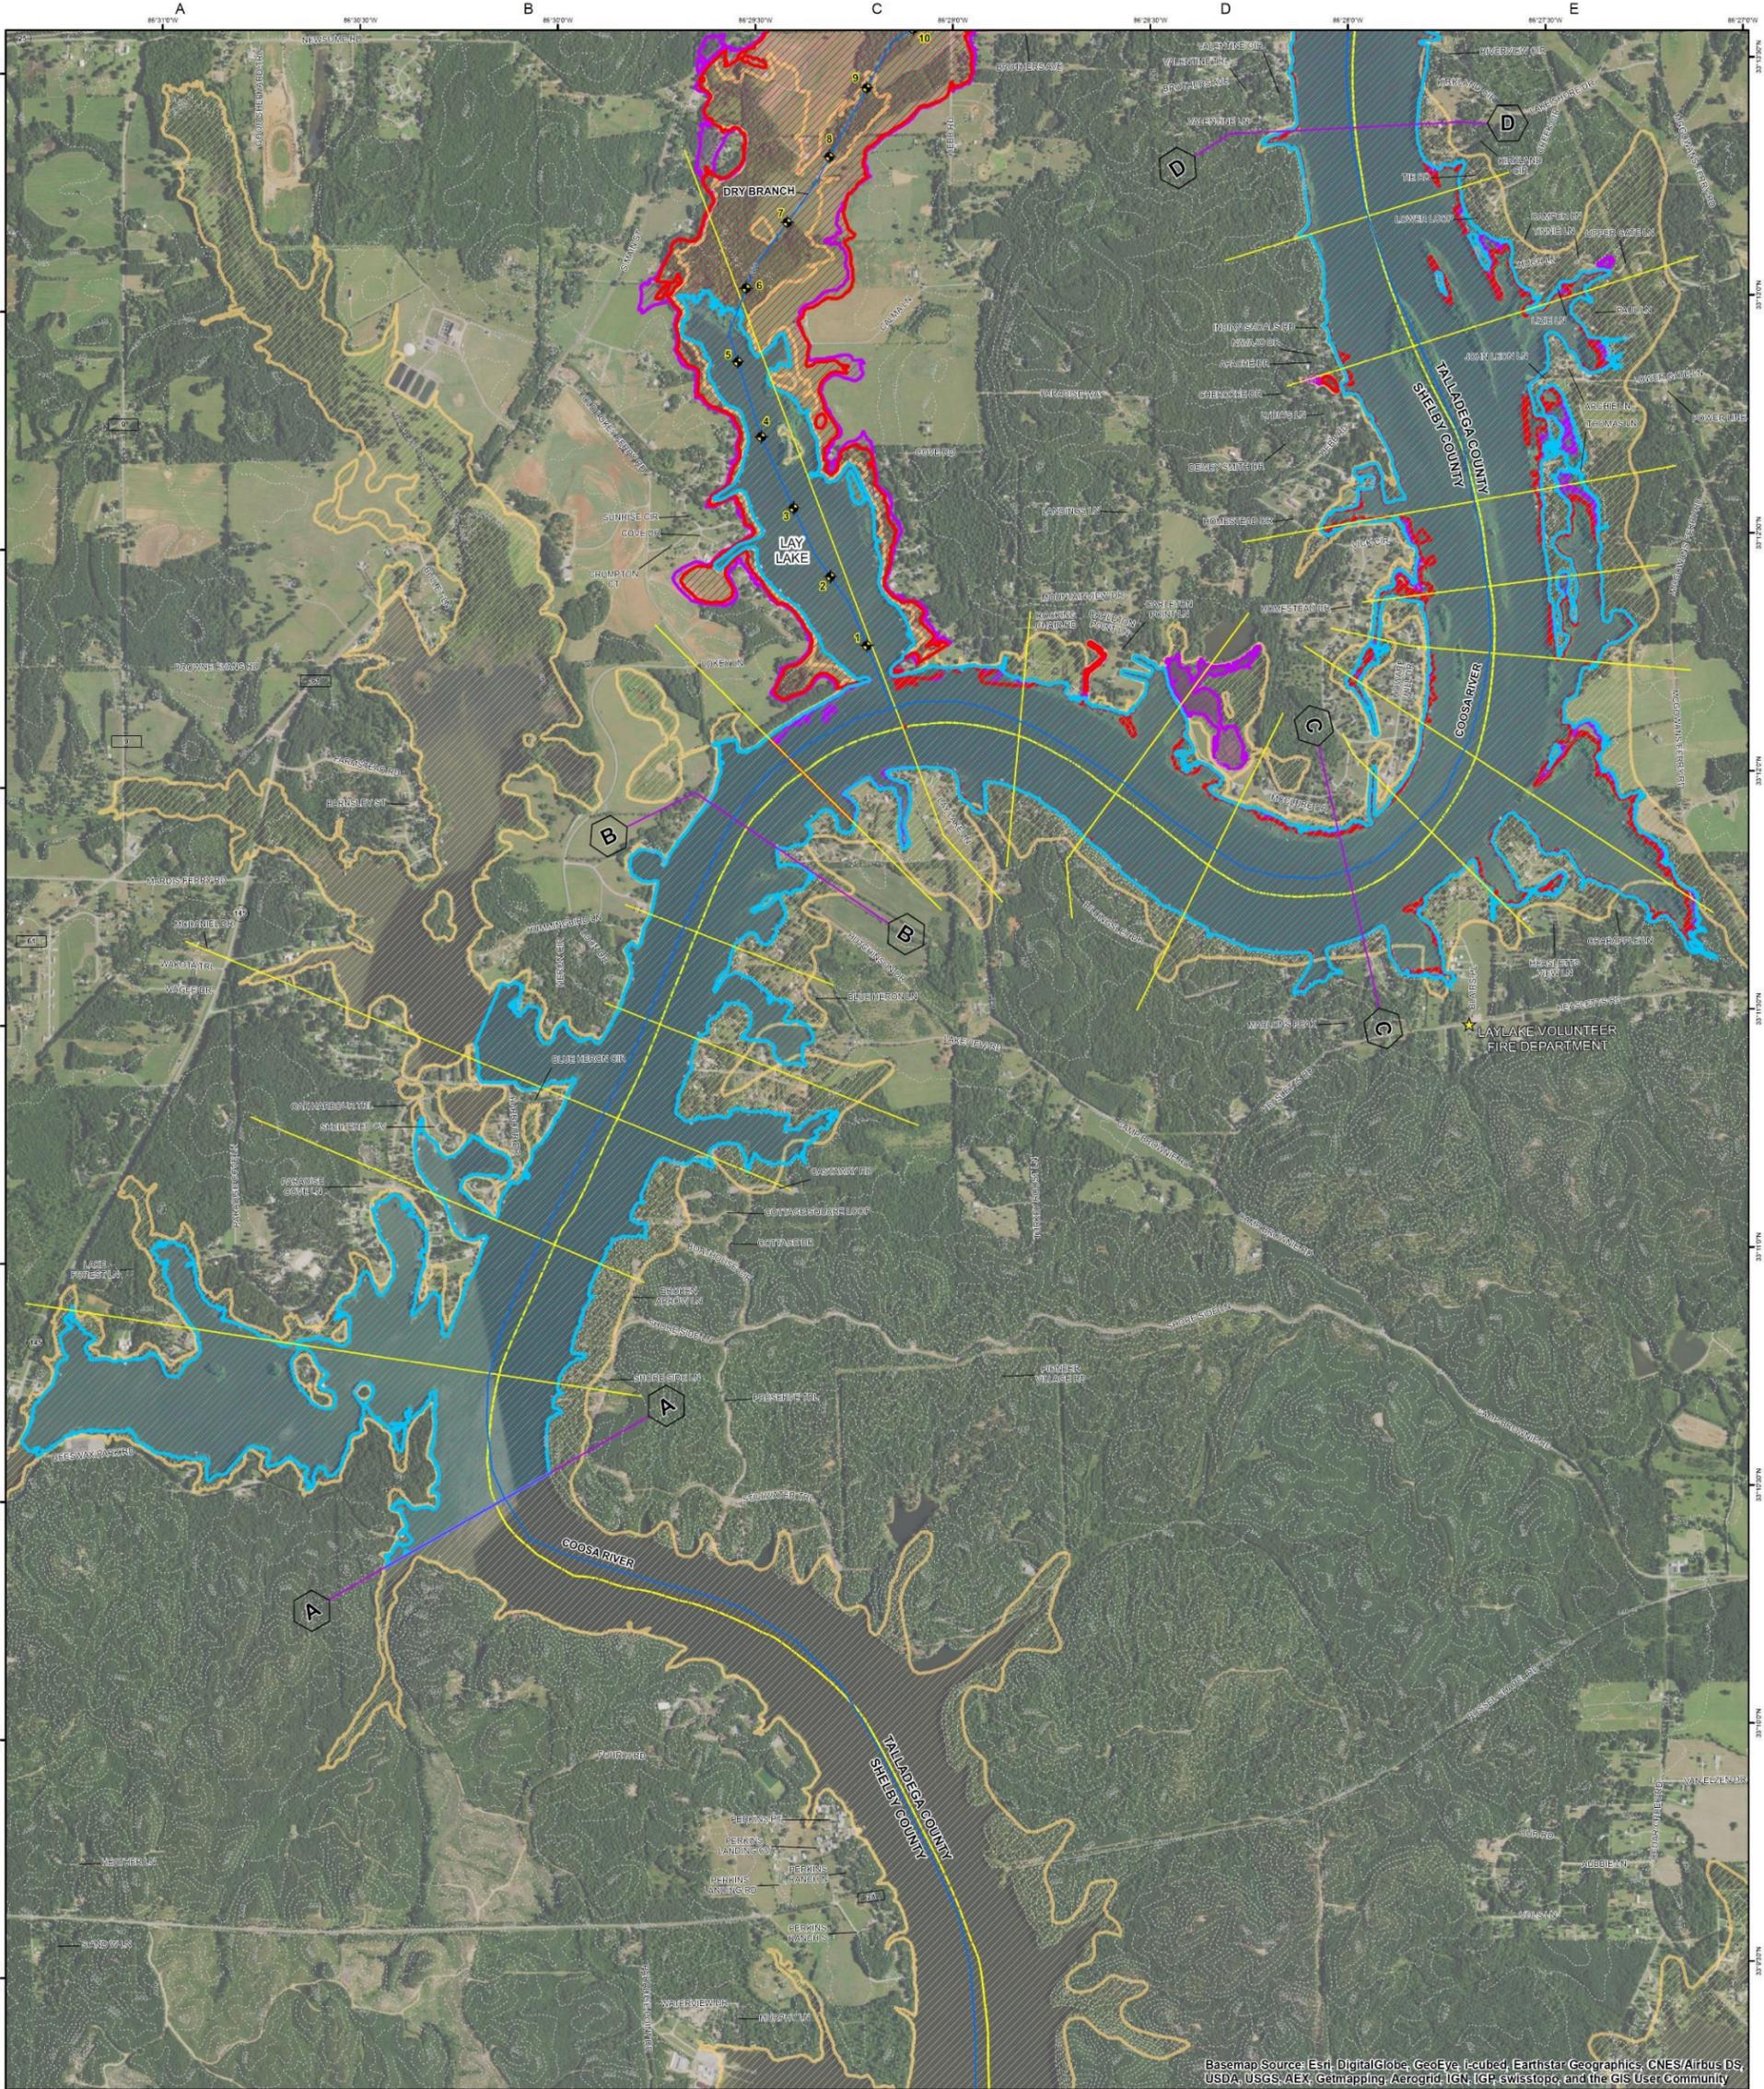
Node/Cross-Section Label	Distance from Dam (miles)	Time to Initial Wave (hours)	Time to Max Wave (hours)	Non-Breach <sup>1</sup> WSEL (NAVD, feet)	Max Breach WSEL (NAVD, feet)	Elevation Increase <sup>2</sup>
A <sup>2</sup>	6.14	0.42	3.63	393.0	396.2	3.2
B <sup>2</sup>	4.33	0.25	3.72	393.9	397.0	3.1
C <sup>2</sup>	2.99	0.17	3.25	394.9	396.0	3.4
D <sup>2</sup>	0.59	0.08	3.20	395.7	400.1	4.4
E <sup>2</sup>	0.00	0.00	3.03	397.4	401.4	4.0
F <sup>2</sup>	0.88	0.08	3.15	398.0	402.0	4.0
G <sup>2</sup>	1.76	0.17	3.20	399.1	402.4	3.3
H <sup>2</sup>	3.56	0.33	3.40	399.8	403.9	4.1

Note:  
 1. The information contained in this map is prepared for use in notification of downstream property owners by emergency management personnel.  
 2. Mapping of flooded areas and floodwave travel times are approximate. Timing and extent of actual inundation may differ from information presented on this map.  
 3. It is prudent to assume that areas outside, but adjacent to, the inundation limits shown could also be flooded.  
 4. The contours shown on this map were generated from the LIDAR Digital Elevation Model (DEM) for Shelby County and the LIDAR DEM for Talladega County.

The Ash Pond dam/dike has been assigned a High Hazard Potential classification under 40 C.F.R. Part 257.73 of the Environmental Protection Agency's (EPA's) Coal Combustion Residuals (CCR) Rule and the State of Alabama's ADEM Admin. Code 335-13-15-.04(4). This classification, by definition, indicates that there is a probable loss of human life in the event of a dam/dike failure or mis-operation of the facility. There are also structures that could be impacted by the failure of the Ash Pond dam/dike or mis-operation of the surface impoundment. Lay Dam is located downstream from the Ash Pond, near Clanton, Alabama. Areas north and west of the Ash Pond in the town of Wilsonville could be impacted by failure of the dam, and some riverbank could also be impacted. The limits of potential flooding in the event of failure of the Ash Pond dam/dike can be seen on the Inundation Maps, which are included as Appendix B. The provided inundation maps were developed based on the results of routing the breach wave downstream using the computer software, HEC-RAS. HEC-RAS is a general application one-dimensional hydraulic model that can perform unsteady flow routing through an open channel system that may also include culverts, bridges, levees, tributaries, storage areas, and other dams. Unsteady flow analyses allow for flow conditions that vary temporally and spatially such as a dam breach simulation. Breach parameters such as failure time, breach width, and breach side slopes were selected from industry accepted empirical formulas. Water surface elevation data was extracted from the hydraulic model and plotted on best available LiDAR topographic information for the downstream areas.

Normal river/lake levels and the flow from simulated dam breaches were superimposed over topographical maps to identify areas subject to flooding. ***These flood extents are provided for planning purposes only; actual flooding can vary due to actual conditions present at the time of the failure.***

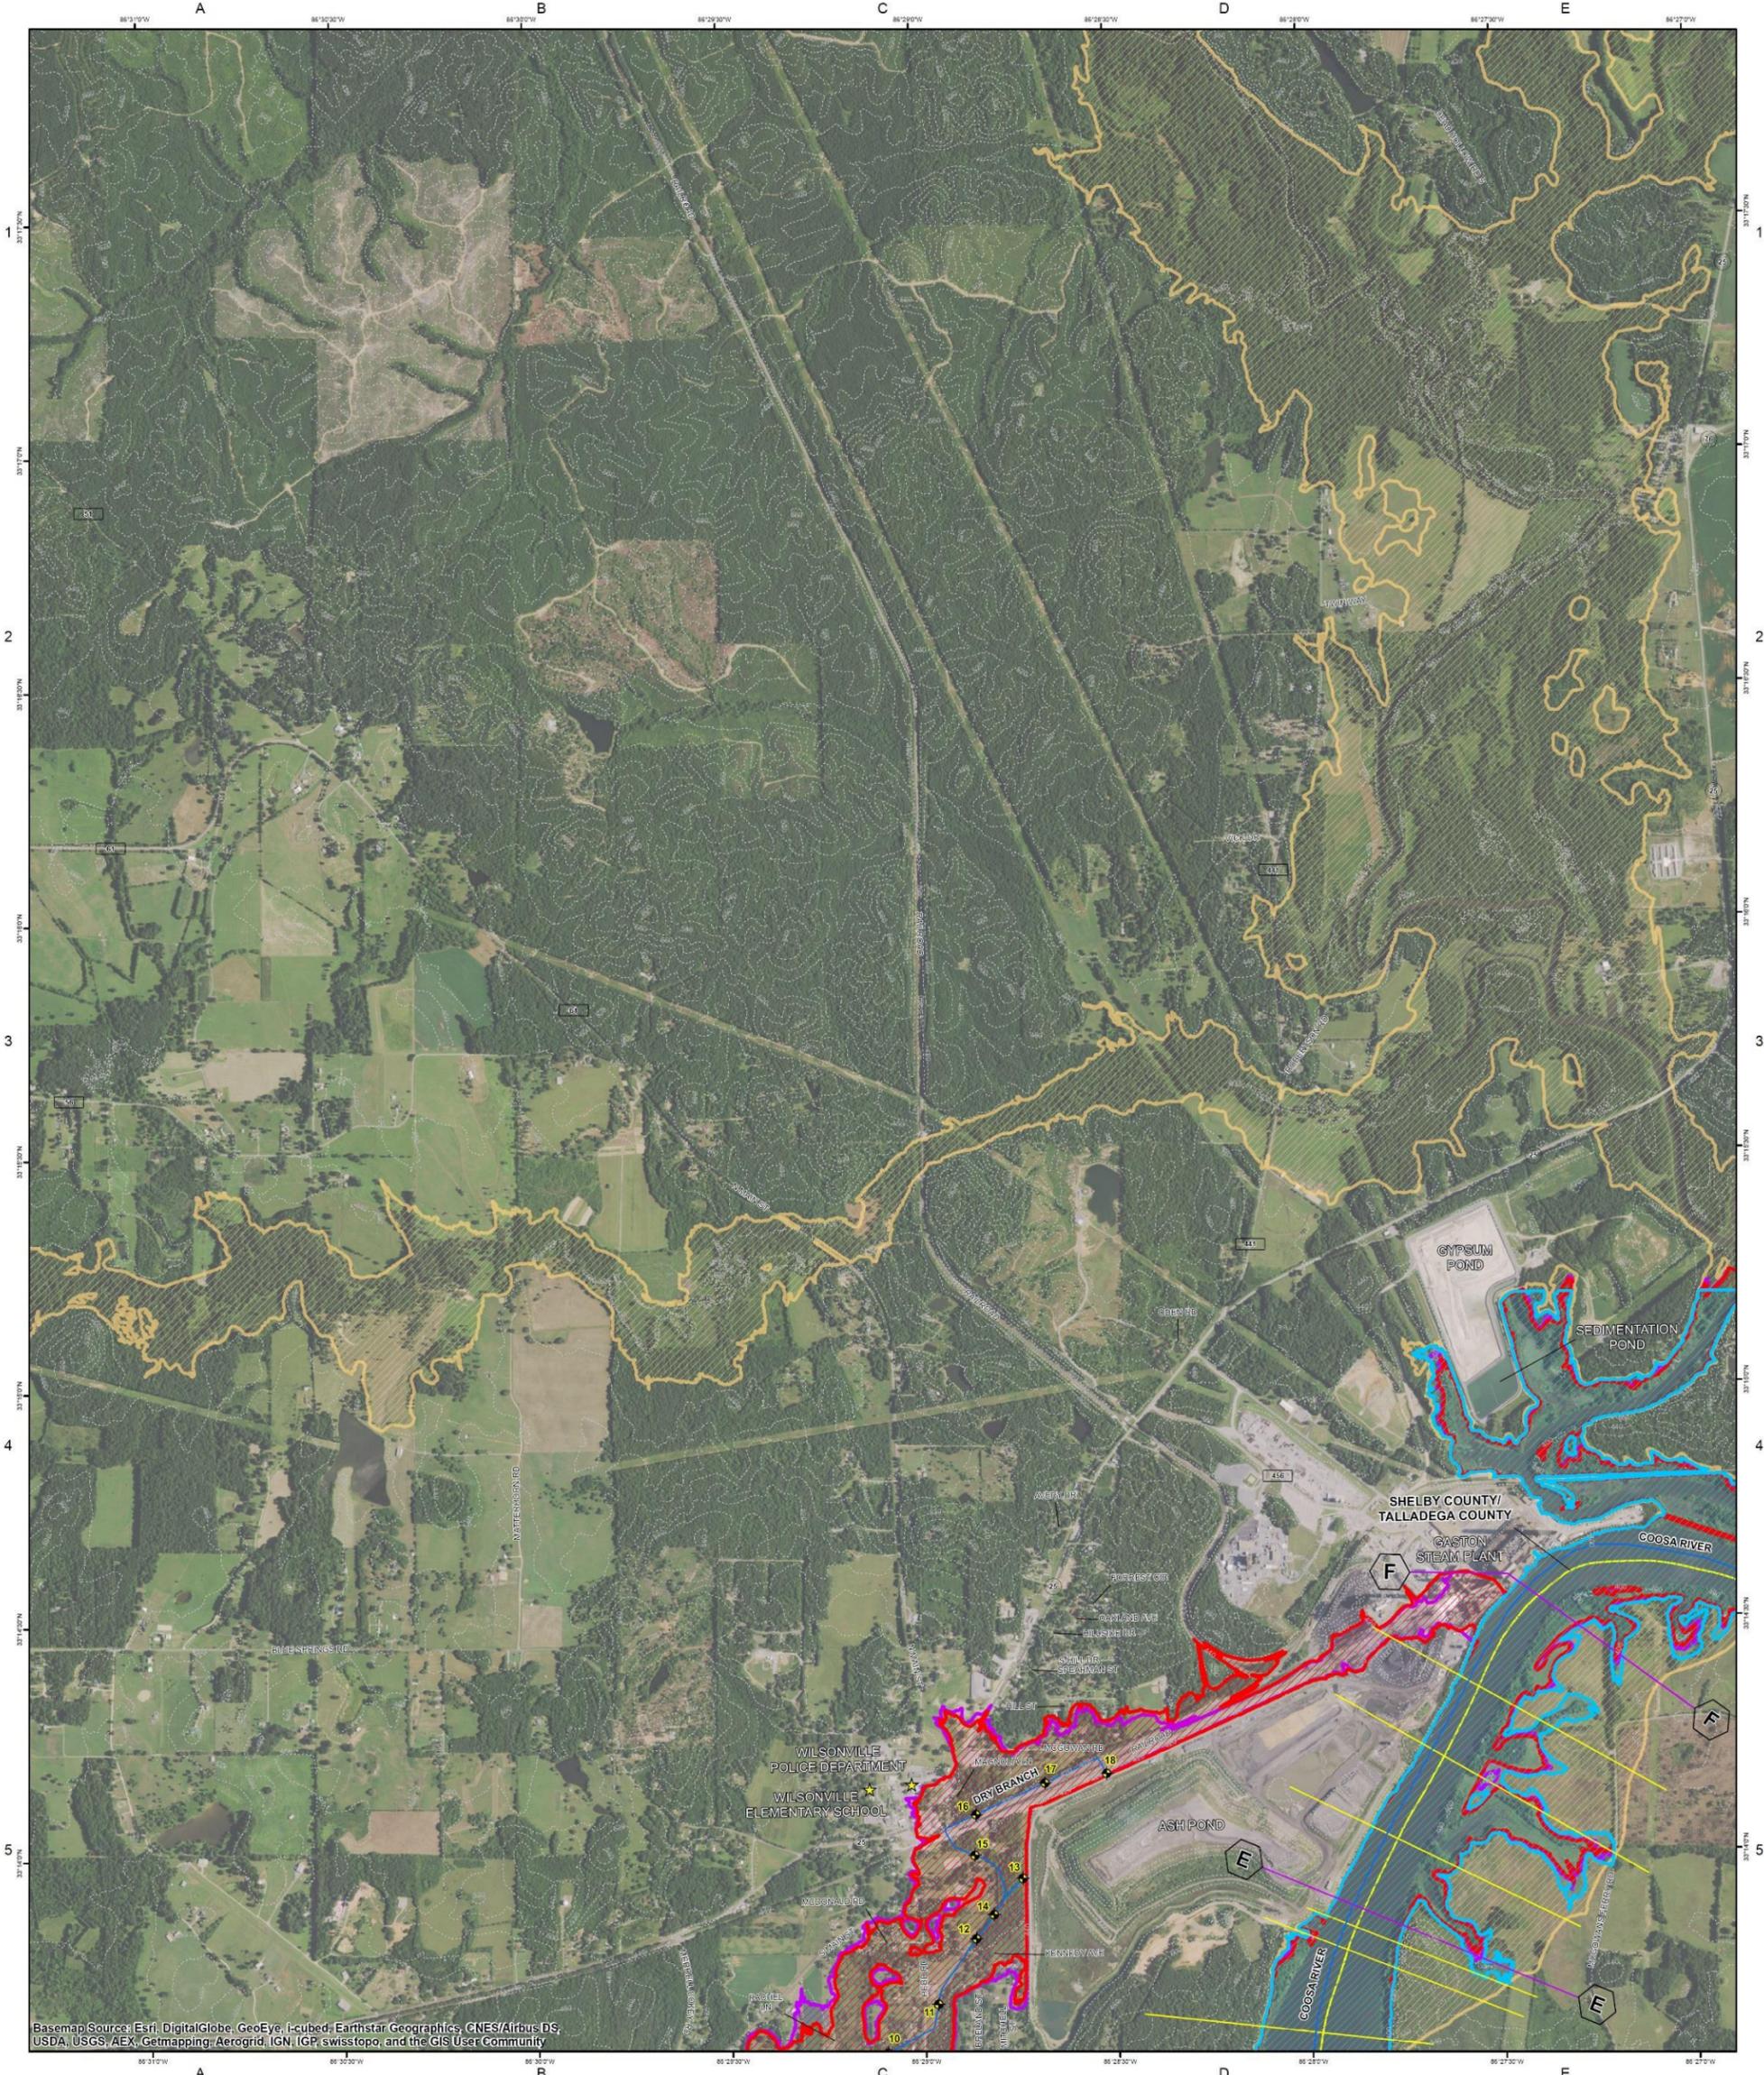
South Embankment Design Storm Breach						
Node/Cross-Section Label	Distance from Dam (miles)	Time to Initial Wave (hours)	Time to Max Wave (hours)	Non-Breach <sup>1</sup> WSEL (NAVD, feet)	Max Breach WSEL (NAVD, feet)	Elevation Increase <sup>1</sup>
A <sup>2</sup>	6.14	0.42	3.63	393.0	396.2	3.2
B <sup>2</sup>	4.33	0.25	3.72	393.9	397.0	3.1
C <sup>2</sup>	2.60	0.17	3.32	394.6	398.0	3.4
D <sup>2</sup>	0.58	0.08	3.20	395.7	400.1	4.4
E <sup>2</sup>	0.00	0.00	3.03	397.4	401.4	4.0
F <sup>2</sup>	0.88	0.08	3.15	398.0	402.0	4.0
G <sup>2</sup>	1.76	0.17	3.20	399.1	402.4	3.3
H <sup>2</sup>	3.56	0.33	3.40	399.8	403.9	4.1

Note:  
 1. The information contained in this map is prepared for use in notification of downstream property owners by emergency management personnel.  
 2. Mapping of flooded areas and floodwave travel times are approximate. Timing and extent of actual inundation may differ from information presented on this map.  
 3. It is prudent to assume that areas outside, but adjacent to, the inundation limits shown could be flooded.  
 4. The contours shown on this map were generated from the LIDAR Digital Elevation Model (DEM) for Shelby County and the LIDAR DEM for Talladega County.

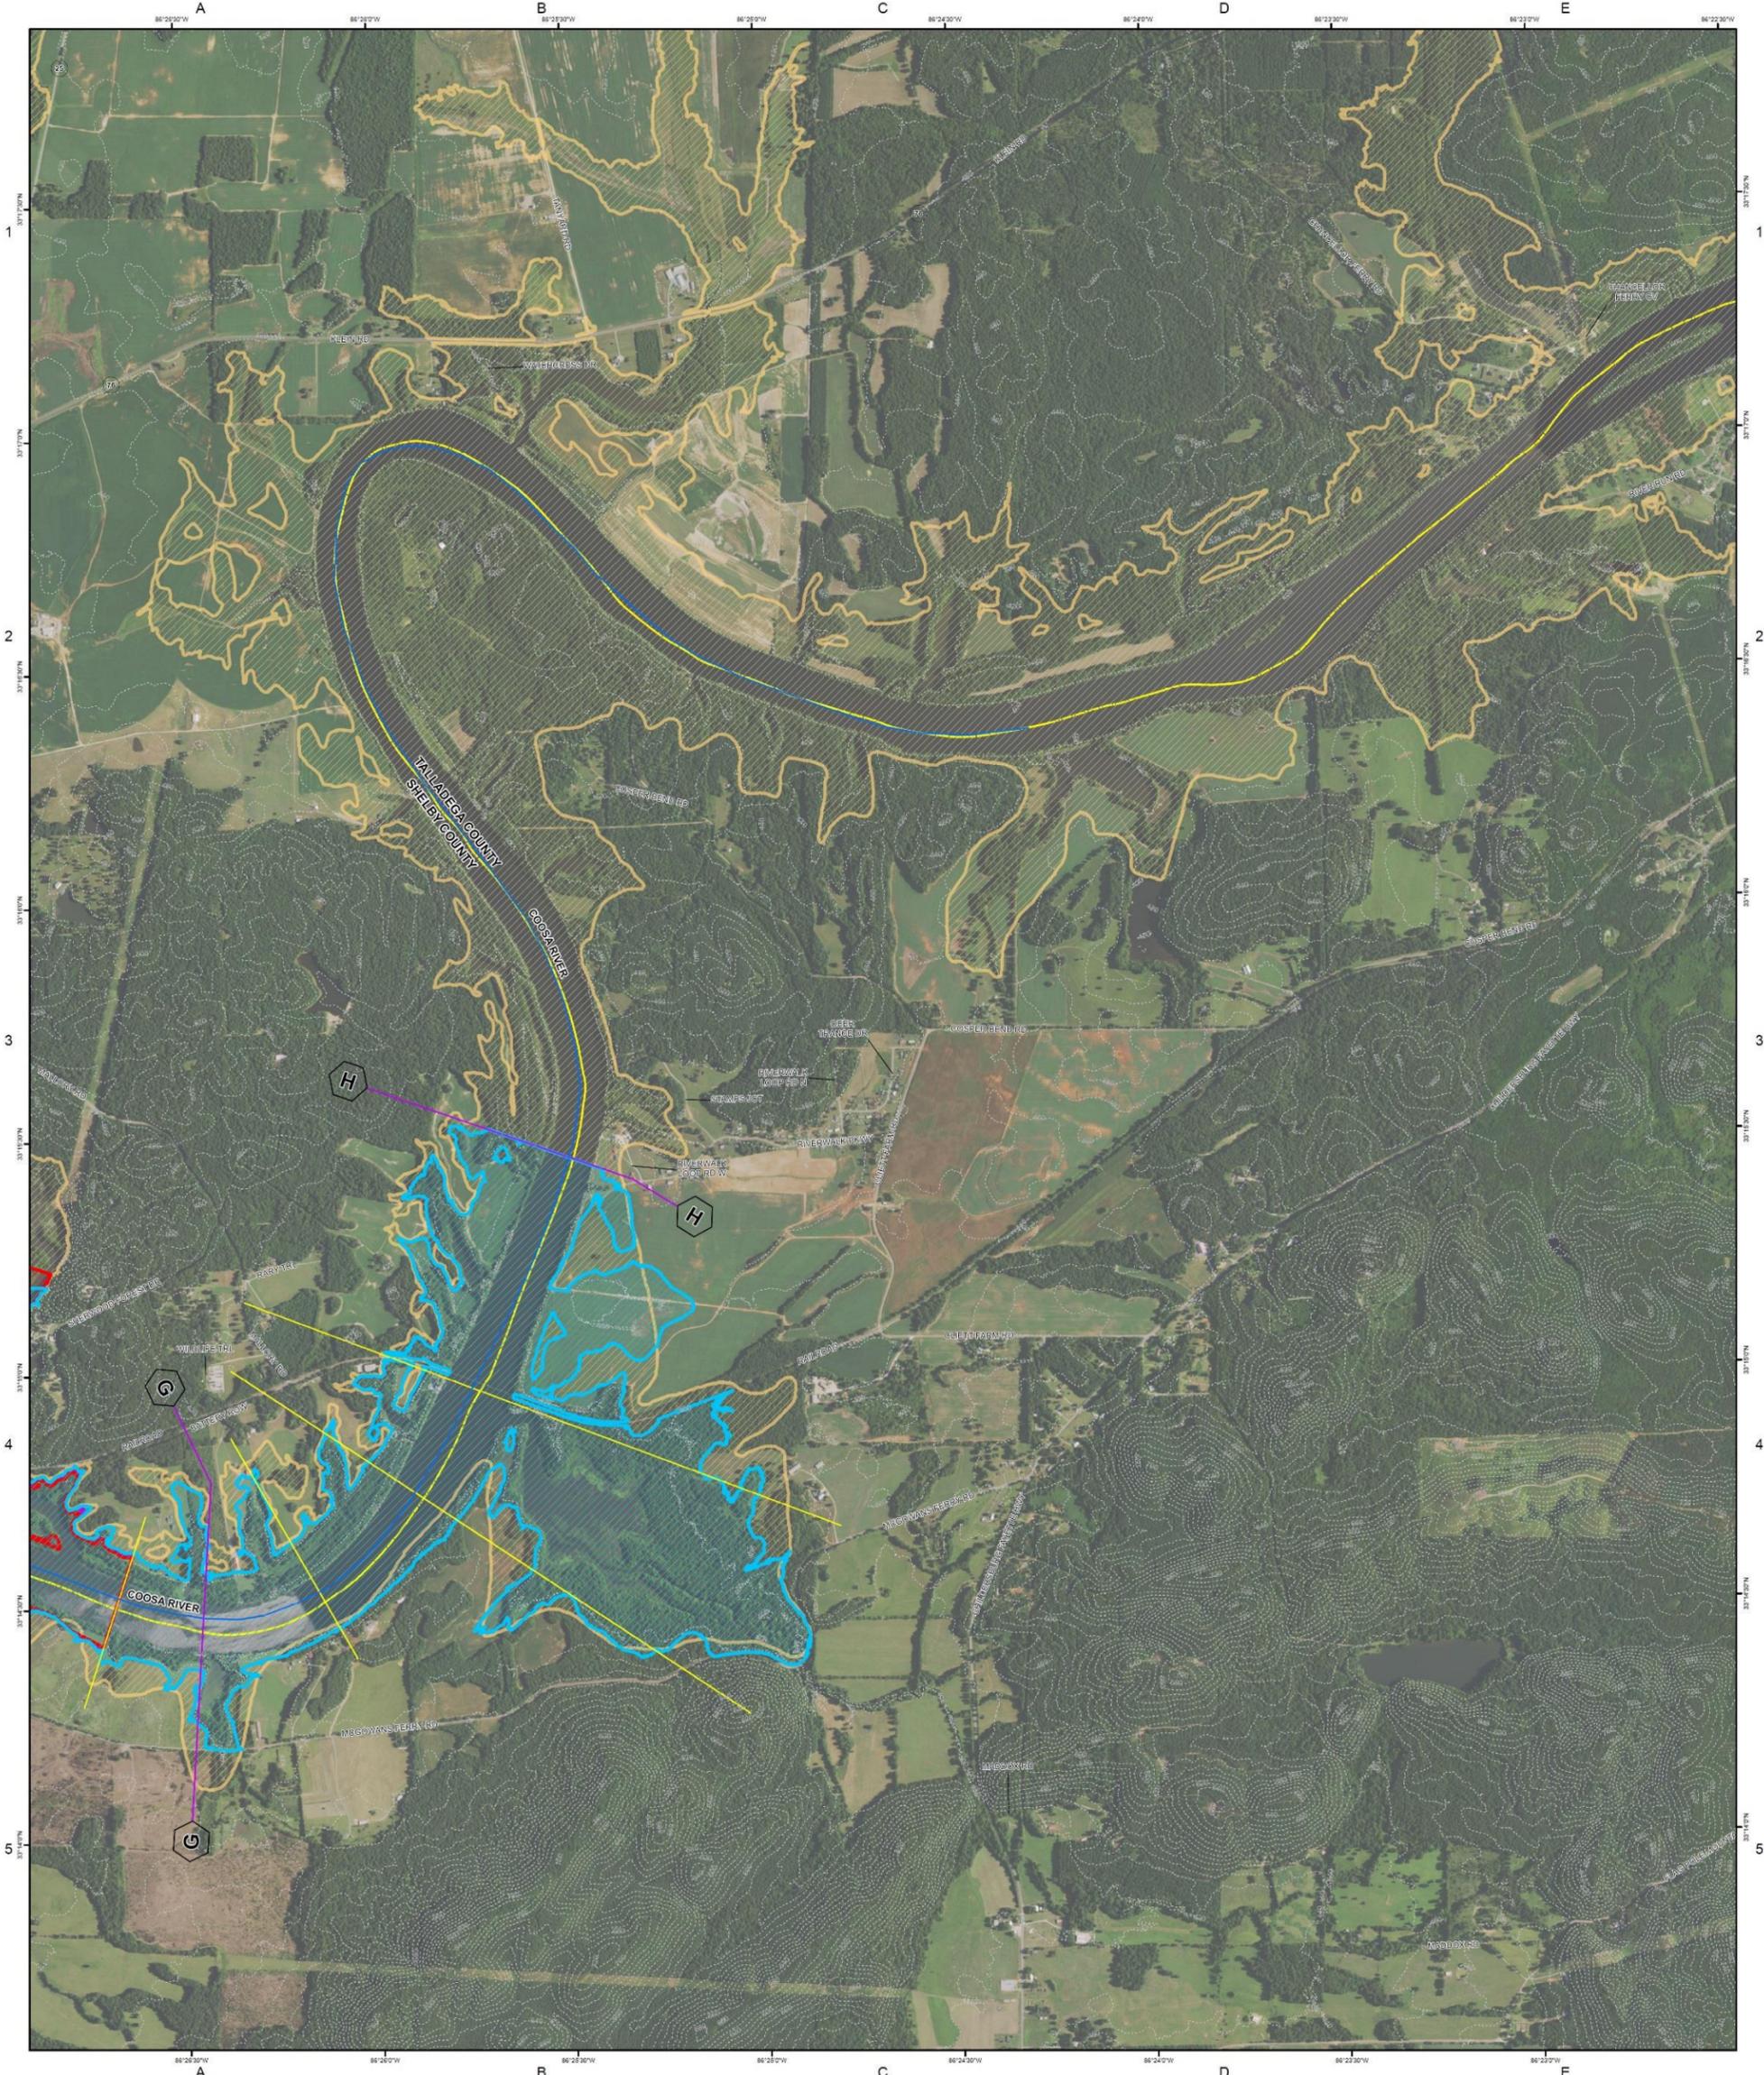
South Embankment Design Storm Breach						
Node/Cross-Section Label	Distance from Dam (miles)	Time to Initial Wave (hours)	Time to Max Wave (hours)	Non-Breach <sup>1</sup> WSEL (NAVD, feet)	Max Breach WSEL (NAVD, feet)	Elevation Increase <sup>2</sup>
A <sup>2</sup>	6.14	0.42	3.63	393.0	396.2	3.2
B <sup>2</sup>	4.33	0.25	3.72	393.9	397.0	3.1
C <sup>2</sup>	2.60	0.17	3.32	394.6	396.0	3.4
D <sup>2</sup>	0.58	0.08	3.20	395.7	400.1	4.4
E <sup>2</sup>	0.00	0.00	3.03	397.4	401.4	4.0
F <sup>2</sup>	0.08	0.08	3.15	399.0	402.0	4.0
G <sup>2</sup>	1.76	0.17	3.20	399.1	402.4	3.3
H <sup>2</sup>	3.56	0.33	3.40	399.8	403.9	4.1

<sup>1</sup> Comparison between the breach and non-breach scenarios  
<sup>2</sup> Cross-sections on the Coosa River downstream of Gaston Ash Pond East Embankment  
<sup>3</sup> Cross-sections on the Coosa River upstream of Gaston Ash Pond East Embankment  
<sup>4</sup> The non-breach water-surface elevations simulate a 10-year event

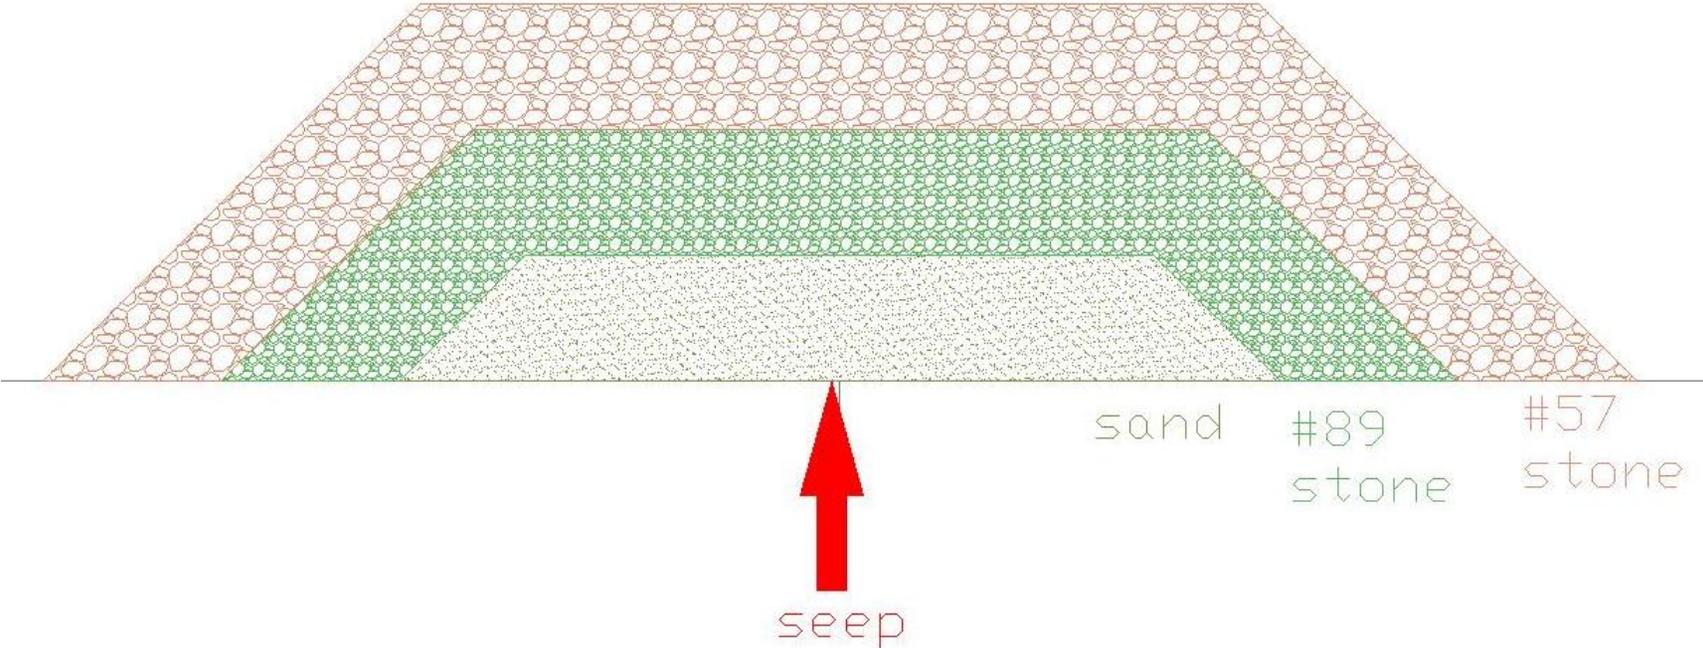
# CROSS SECTION OF A REVERSE FILTER OVER A SEEP OR BOIL

**Filter fabric or geotextile is not acceptable as a substitute for the sand. The fabric tends to smear and clog if applied in a wet situation.**
