# CCR SURFACE IMPOUNDMENT EMERGENCY ACTION PLAN

## Plant Gaston Ash Pond

**ISSUE DATE:** April 17, 2017  
**REVISION #:** 0

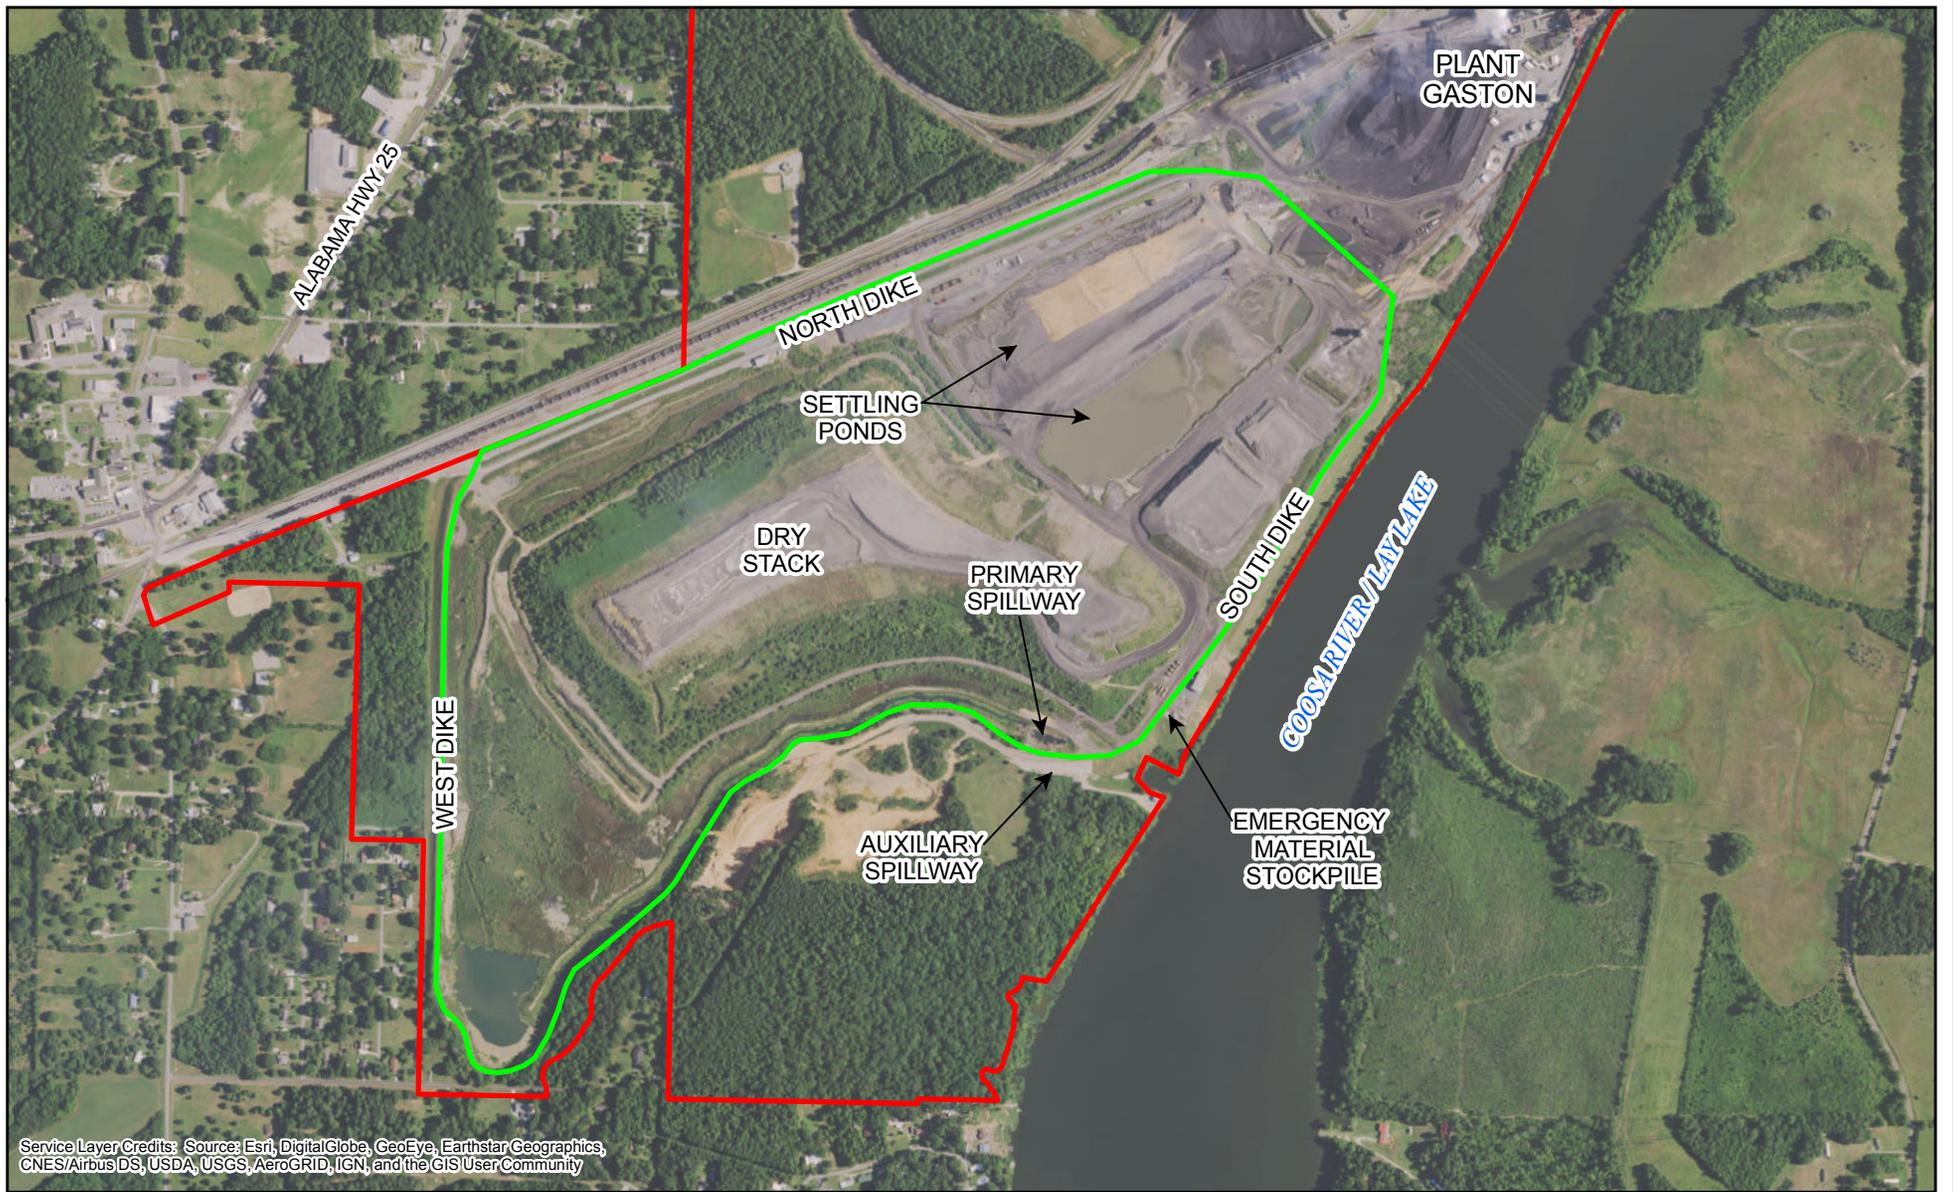
**FIGURE 2**  
**ASH POND OVERVIEW**  
**PLANT GASTON**  
**SHELBY COUNTY, GEORGIA**

The ash pond is approximately 263 acres in size at its normal pool elevation of 432 feet (Appendix A – Figure 2). It should be noted that a significant portion of the 263 acres is utilized for dry ash storage and contains no standing water. The Ash Pond has earthen embankments (also referred to as dam/dike) on its north, west, east sides, and the portion of the south side where it parallels the Coosa River. The south, west, and north dikes have heights of 45 feet, 30 feet, and 25 feet, respectively. The area between the east dike and the coal pile embankment has been filled to the approximate crest elevation of the east dike. The elevation of the crest of the dikes is 444 feet to 449 feet. The crest surface is composed of grass and a gravel access drive. Downstream slopes are covered with either grass or riprap.

Plant and emergency personnel are able to access the dam/dike from the main portion of Plant Gaston by paved or gravel-surfaced roadways. Figures 1 and 2 in Appendix A illustrate the location of the Ash Pond within the Plant property.
